DLG Test Report 6160 F

Leica Geosystems mojoXact with mojo3D Terminal

Automatic Steering Systems

10/13 **Automatic
Steering Systems**

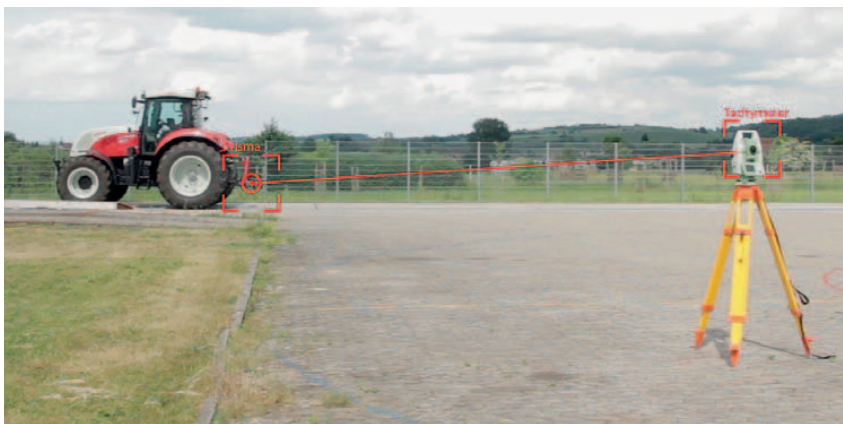
Figure 2:
Measurement setup of the optical reference system

The accuracy of the automatic steering system was determined by measurement with an optical reference system. Here, a tacheometer automatically follows a prism attached to the harvester's cutting-bar mount and records the measured values. The test setup is shown in Figure 2.

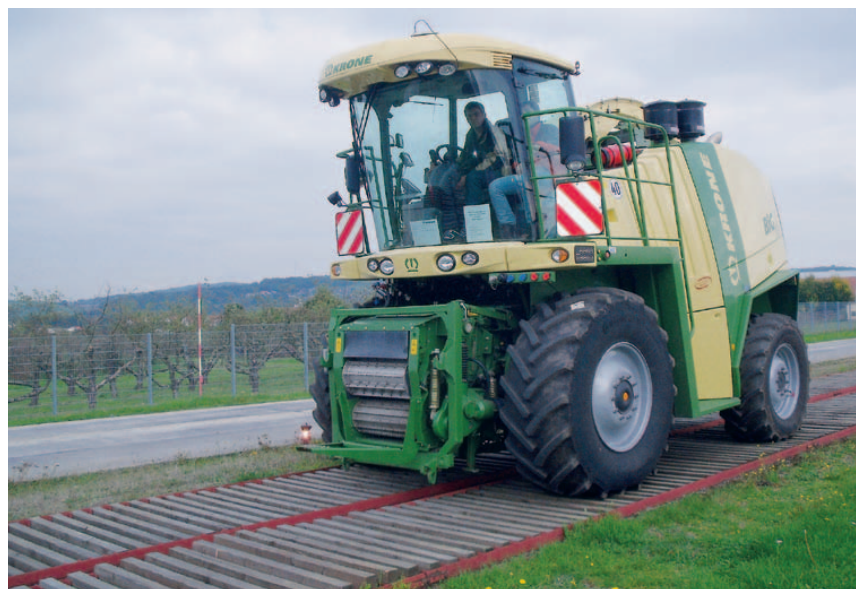
*Figure 4:
Driving on the beam track at the DLG Test Center Technology
and Farm Inputs*

The steering system's dynamic behaviour on an uneven track was simulated reproducibly on a beam track according to the 78/764/EWG standard in order to measure the cabin and seat comfort (see Figure 4). The industry-standard practice of mounting the GNSS antenna on the cabin's roof leads to varying lateral deviations as a result of the uneven track and the cabin's suspension; these deviations must be corrected by the steering system.

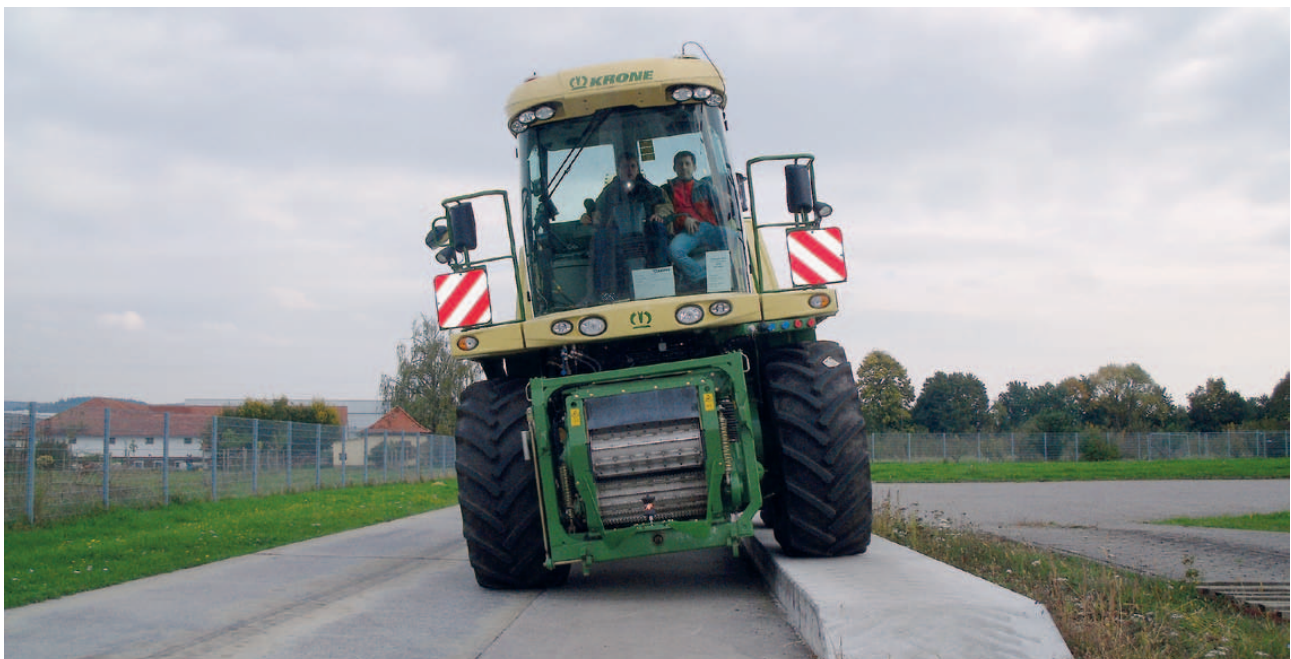
*Figure 5:
Driving on the inclined track, 25 cm high*

To check the dynamic behaviour while entering and exiting an inclined track with a height of 25 cm (Figure 5), this test also shows the effectiveness of the integrated tilt compensation.

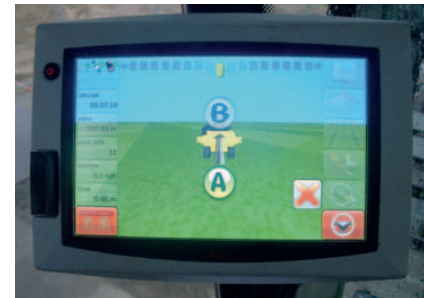
Figure 6:
Control and display elements

With regard to the system's operation, it took four operating steps to teach in an A-B path, leading to an assessment of [+] = "Better than standard". The subsequent simple activation of the automatic steering function is achieved very easily via a release switch in the armrest and by

pushing a button on the device's joystick; this was also assessed as [+] = "Better than standard".

The display is mounted on the right front bar in a low-vibration manner and can be adjusted both horizontally and vertically. Though relatively small at 7", it still provides excellent legibility, leading to an assessment of [+] = "Better than standard" in both categories. The brightness can be adjusted manually. The legibility is therefore [o] = "Standard"

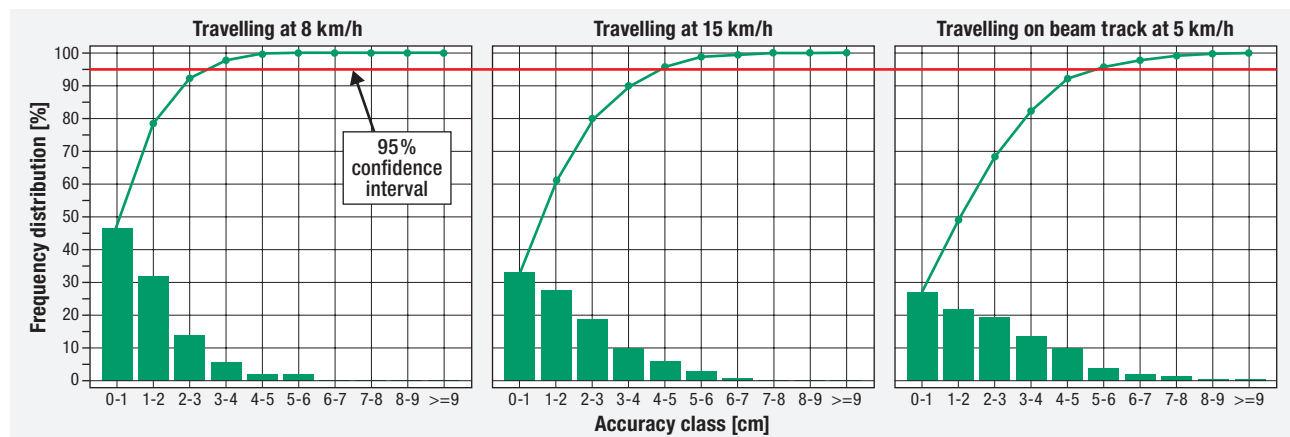
Figure 7:
Deviation rates (A-B run on a level track at 8 or 15 km/h and on a beam track at 5 km/h)

As shown by the example of the A-B runs at 8 or 15 km/h on a level track in Figure 7, the 95 % class of deviations is determined using the frequency distribution and the deviation class. At a driving speed of 8 km/h, as well as in the long-term test after more than 24 hours, the system achieved accuracy in the 4 cm class in 95 % of cases. The other results are summarised in Table 3 and Figures 7 and 8.

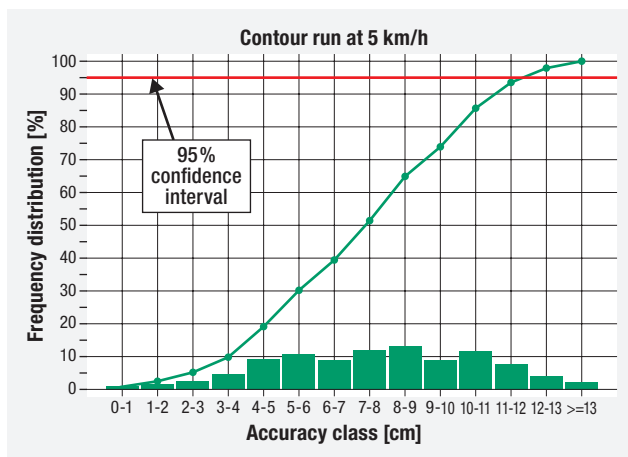
Figure 8:
Deviation rates (contour run at 5 km/h)

To determine the accuracy in a contour run, a reference line was manually driven along the semi-circular section of the test track and recorded by the steering system. The deviation in the error class is expressed in relation to the reference run.

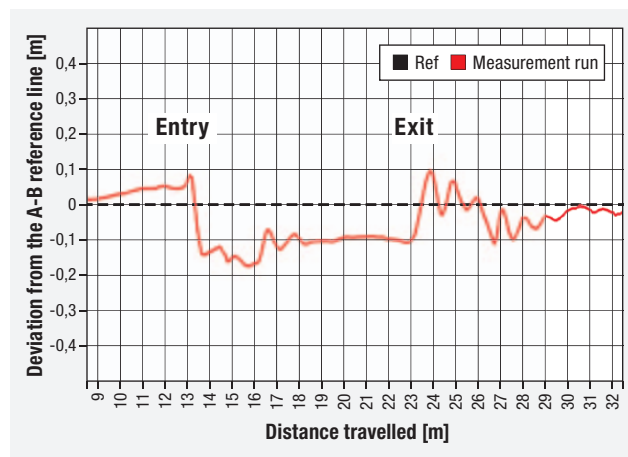
Figure 9:
Comparison of reference/measurement run
on the inclined track

The representation of the A-B run on the inclined track at 5 km/h (Figure 9) shows how the system responds during gradient compensation. The offset on the plateau of the ramp was approx. 10 cm. On entering the ramp, there was a brief overshoot in the region of approx. 17 cm; on exiting, this was in the range of approx. 10 cm.
