DLG Test Report 6161 F

Maschinenfabrik Bernard Krone GmbH Reichhardt PSR ISO Top

Automatic Steering Systems

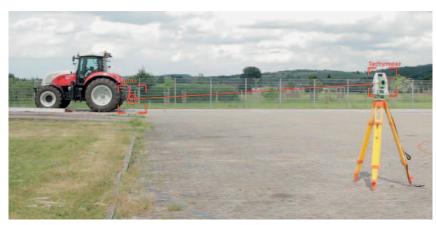
Figure 2: Measurement setup of the optical reference system

The accuracy of the automatic steering system was determined by measurement with an optical reference system. Here, a tacheometer automatically follows a prism attached to the harvester's cutting-bar mount and records the measured values. The test setup is shown in Figure 2.

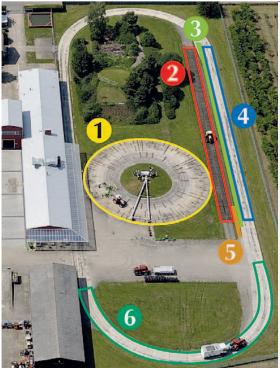
Figure 3:
Measurement tracks on the testing ground

① = Checking the tacheometer for radial run-out

- (2) = Bumpy track
- 3 = A-B run with offset
- \bigcirc = A-B run
- (5) = Gradient
- 6 = Contour

The measurements were taken on the testing ground of the DLG Test Center Technology and Farm Inputs in Groß-Umstadt (see Figure 3) and were accompanied by one of the manufacturer's staff. All settings were configured according to the manufacturer's specifications. The following measurements were taken:

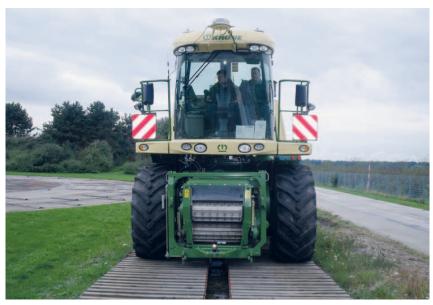
Figure 4:
Driving on the beam track at the DLG Test Center Technology and Farm Inputs

The steering system's dynamic behaviour on an uneven track was simulated reproducibly on a beam track according to the 78/764/EWG standard in order to measure the cabin and seat comfort (see Figure 4). The industry-standard practice of mounting the GNSS antenna on the cabin's roof leads to varying lateral deviations as a result of the uneven track and the cabin's suspension; these deviations must be corrected by the steering system.

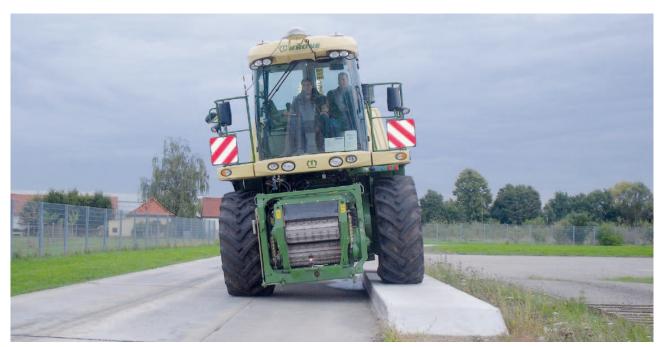
Figure 5: Driving on the inclined track, 25 cm high

To check the dynamic behaviour while entering and exiting an inclined track with a height of 25 cm (Figure 5), this test also shows the effectiveness of the integrated tilt compensation.

The representation of the A-B run on the inclined track at 5 km/h (Figure 9) shows how the system responds during gradient compensation. The offset on the plateau of the ramp was approx. 0–15 cm. On entering the ramp, there was a brief overshoot in the region of approx. 18 cm; on exiting, this was in the range of approx. 35 cm.

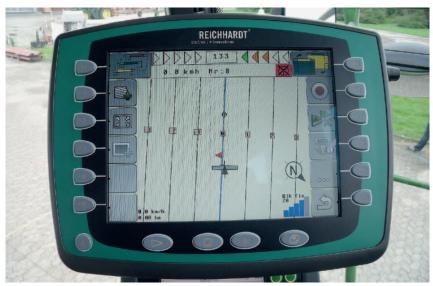
Figure 6: Control and display elements

the device's joystick; this was assessed as [+] "Better than standard". The terminal's user interface makes a positive impression with its simple and clear structure. The overall assessment of the operation is therefore [+] = "Better than standard".

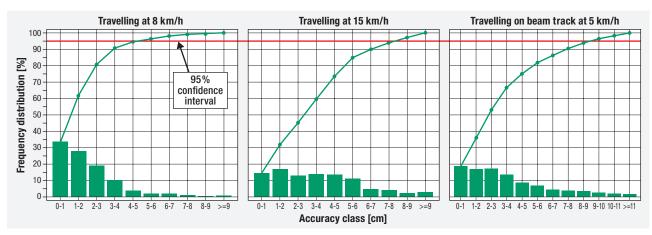
Figure 7: Deviation rates (A-B run on a level track at 8 or 15 km/h and on a beam track at 5 km/h)

As shown by the example of the A-B runs at 8 or 15 km/h on a level track in Figure 7, the 95 % class of deviations is determined using the frequency distribution and the deviation class. At a driving speed of 8 km/h, the system achieved accuracy in the 6 cm class in 95 % of cases; the same applies to the long-term test after more than 24 hours. The other results are summarised in Table 3 and Figures 7 and 8.
